Technical Bulletin #2

Sterling B-Vent Spill Switch Correction

Publication Date: May 24, 2001

Re: Sterling "G" Series, B-Vent Only (Model 8521)

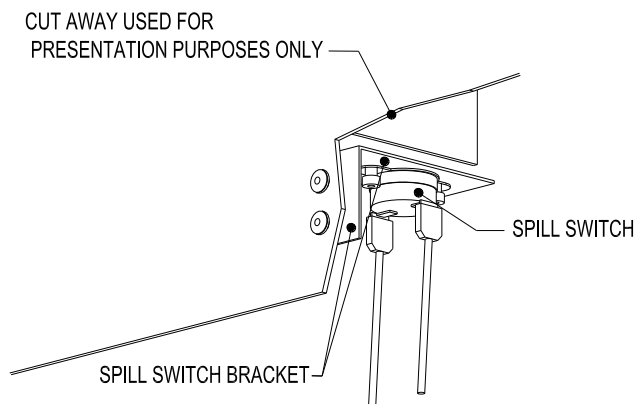
Figure 1: Incorrect

Problem Description: The bracket that holds the spill switch in the draft hood may have been installed upside down at the factory. This would increase the sensitivity of the switch causing the stove to shut down excessively. If you have a customer that reports nuisance shut downs, check to ensure that the spill switch bracket is installed correctly (Figure 2).

The Fix: The bracket is held in place by two "pop" rivets. Using a 1/8" drill bit, drill out the rivets that hold the bracket to the draft hood and the spill switch to the bracket. Turn the bracket over and reattach the spill switch to the bracket and the bracket to the draft hood with new 1/8" pop rivets or with small nuts and bolts with lock washers.
