# Technical Data Sheet

## Clydesdale 8492 Bypass Door Retaining Clip Replacement

*Kit 94-49921*

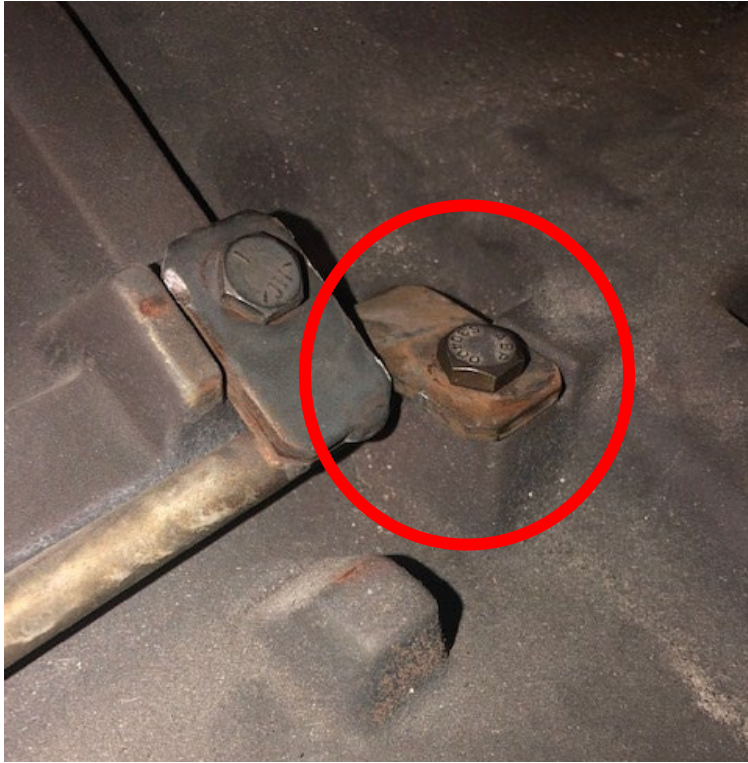
**Figure 1.**

- 4) Locate the bypass rod retaining bolts, from within the flue collar opening. See **figure 1** for detail. There are 2 bolts, 1 on each side of the bypass door. These can be removed with a 7/16" wrench. Save the bolts for reinstallation, the retaining clips can be discarded.

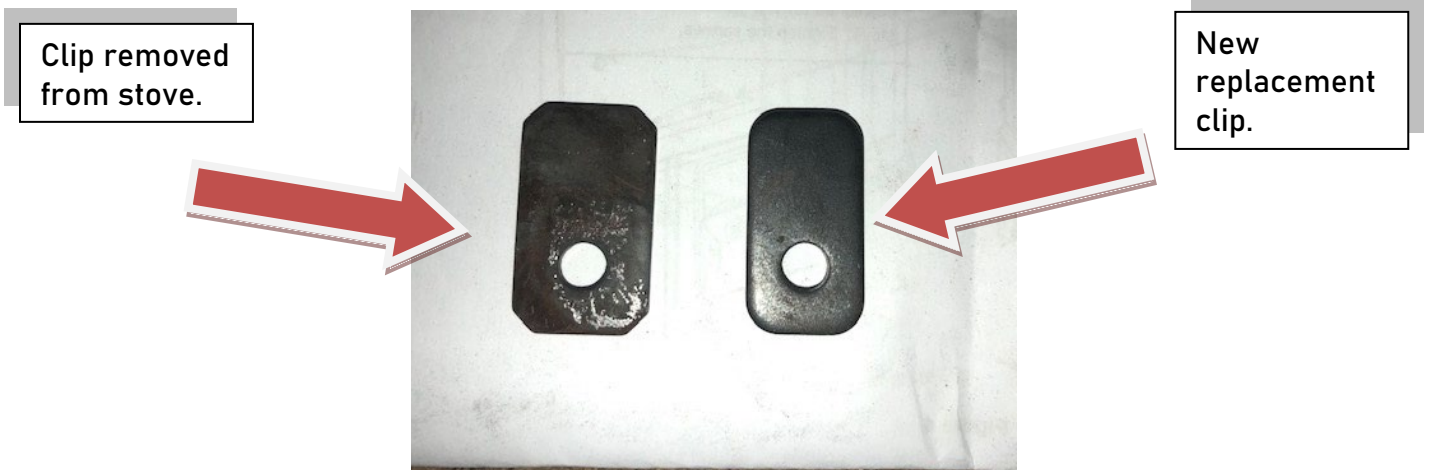
**Figure 2.**

**Figure 2** shows a side-by-side comparison of the old retaining clip, and the new retaining clip.

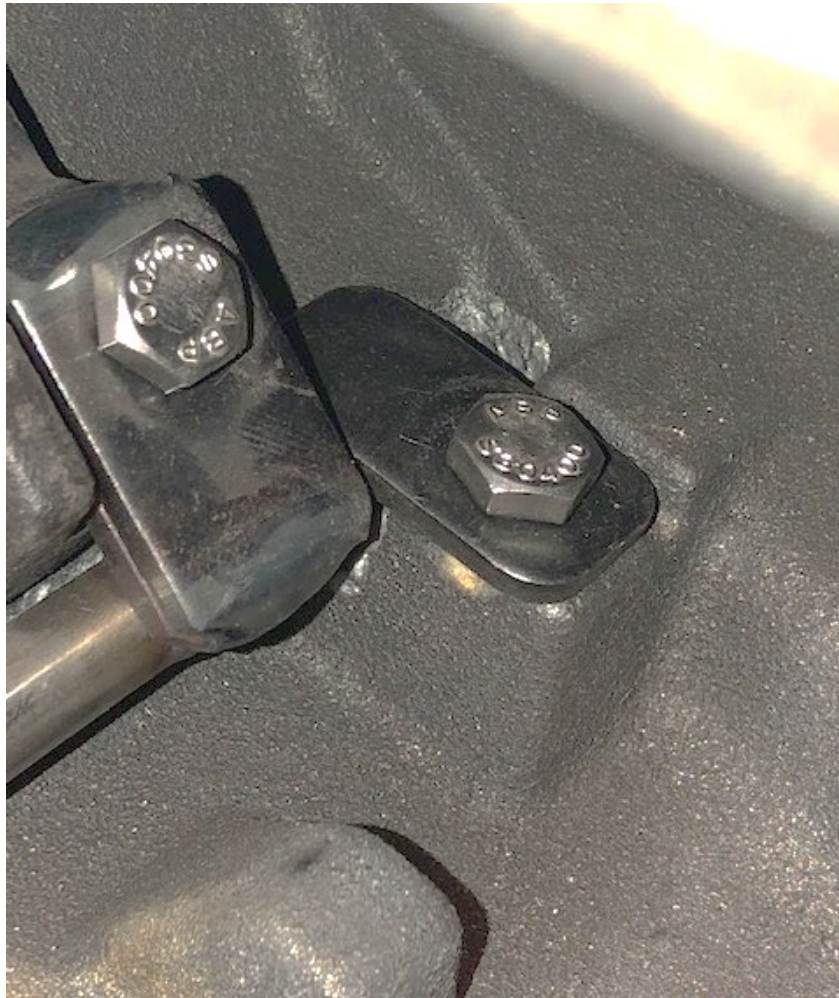
**Figure 3**

- 5) **Installing the new clips.** The alignment of the new clips is crucial. They must be installed parallel to the adjacent clips. Crooked clips *may* result in a binding bypass door during the heating cooling cycle. With the clips parallel, tighten the bolts using a 7/16" wrench, as shown in **Figure 3**.

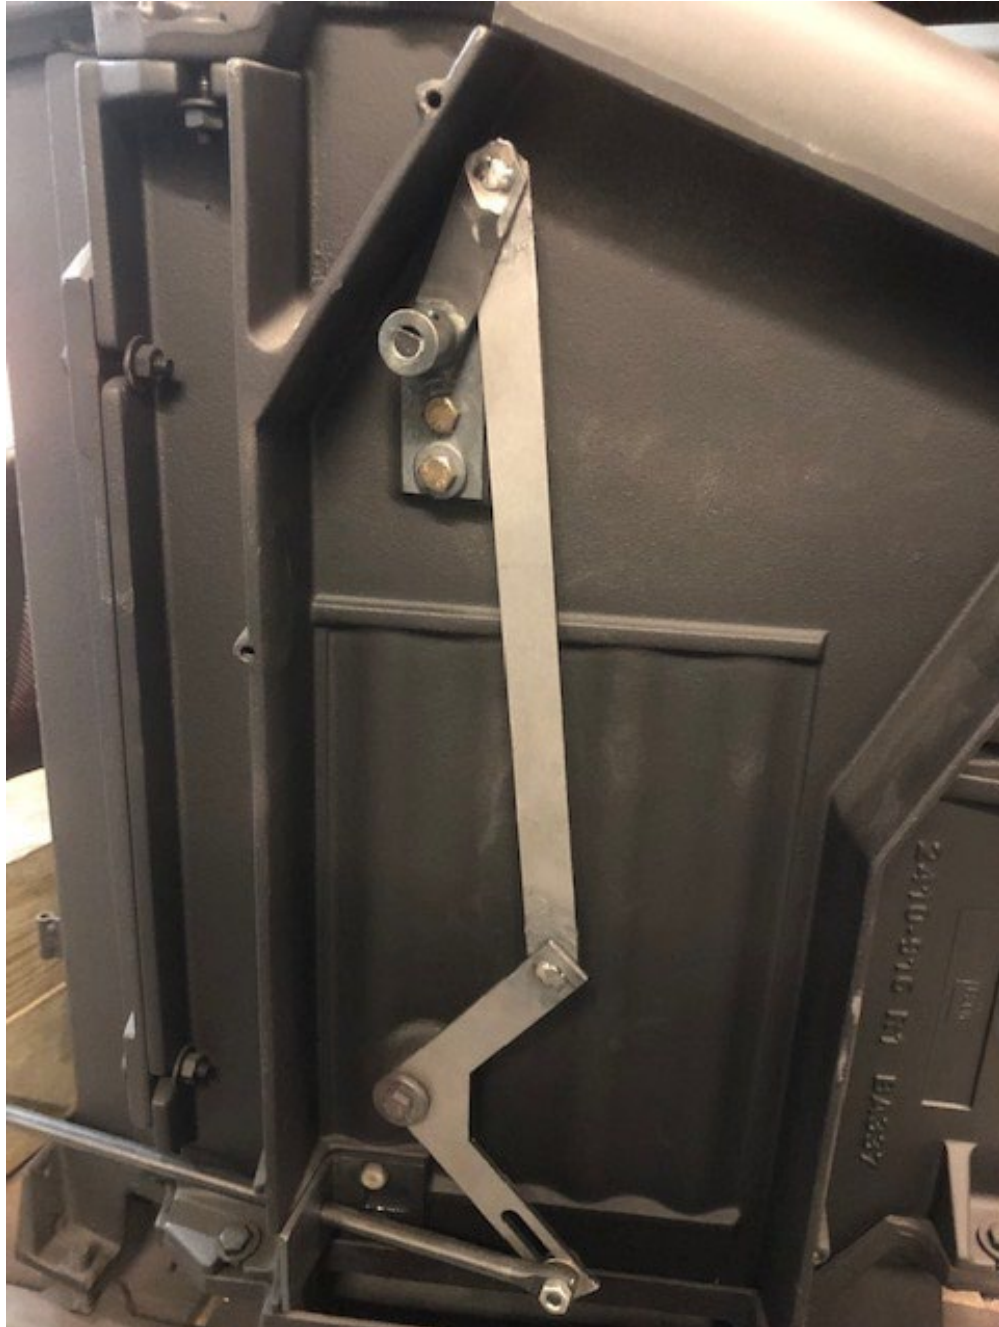
**Figure 4**

- 6) The bypass linkage can be found on the right side of the stove, as shown in **figure 4**.

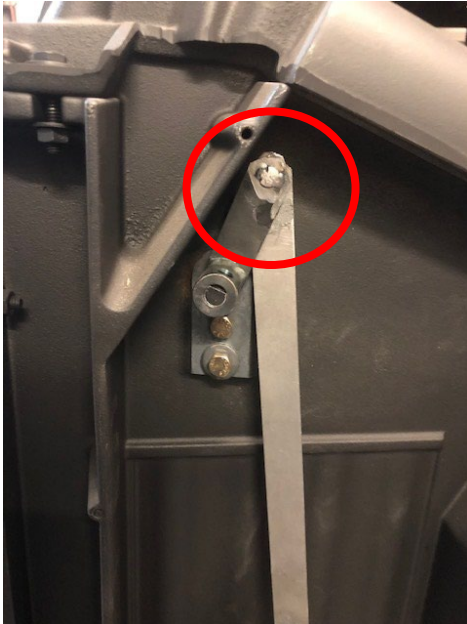
**Figure 5**

- 7) Use Emery cloth to deburr the edges of the linkage. Focus on the pivot points, and where the two linkage arms overlap one another, as shown in **figure 5, 6 and 7**. Once deburred, apply moly-grease to the pivot points
