Technical Data Sheet

Replacing the Torsion Spring on The Heritage 8022

Part #5240-143

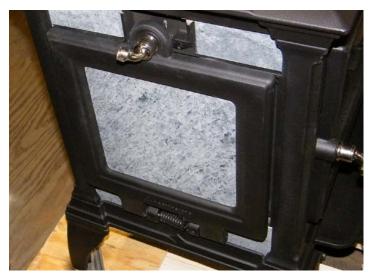
Photo #9

6. Close and latch the door with the frame removed to continue the repair as shown in photo #9.

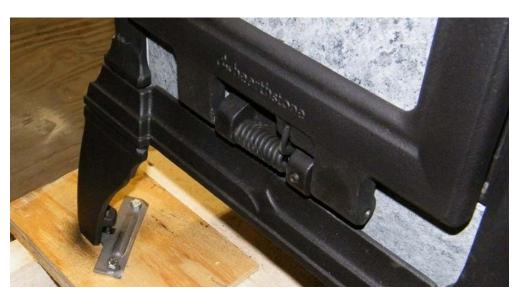
Photo #14

9. Install the new tension spring. The longer end of the spring must be upright and positioned in the slot in the door (see photo #14). <u>IMPORTANT NOTE</u>: When installing the replacement spring, the bottom (shorter) end of the spring should be positioned below the hole where the original spring was installed (as shown in photo#13). This will allow for the proper tension when opening and closing the door.
