Technical Data Sheet

Mansfield 8010/11, Homestead 8570, and Heritage 8020* Front Door Latch Coil Spring Upgrade Kit

Kit 90-73112

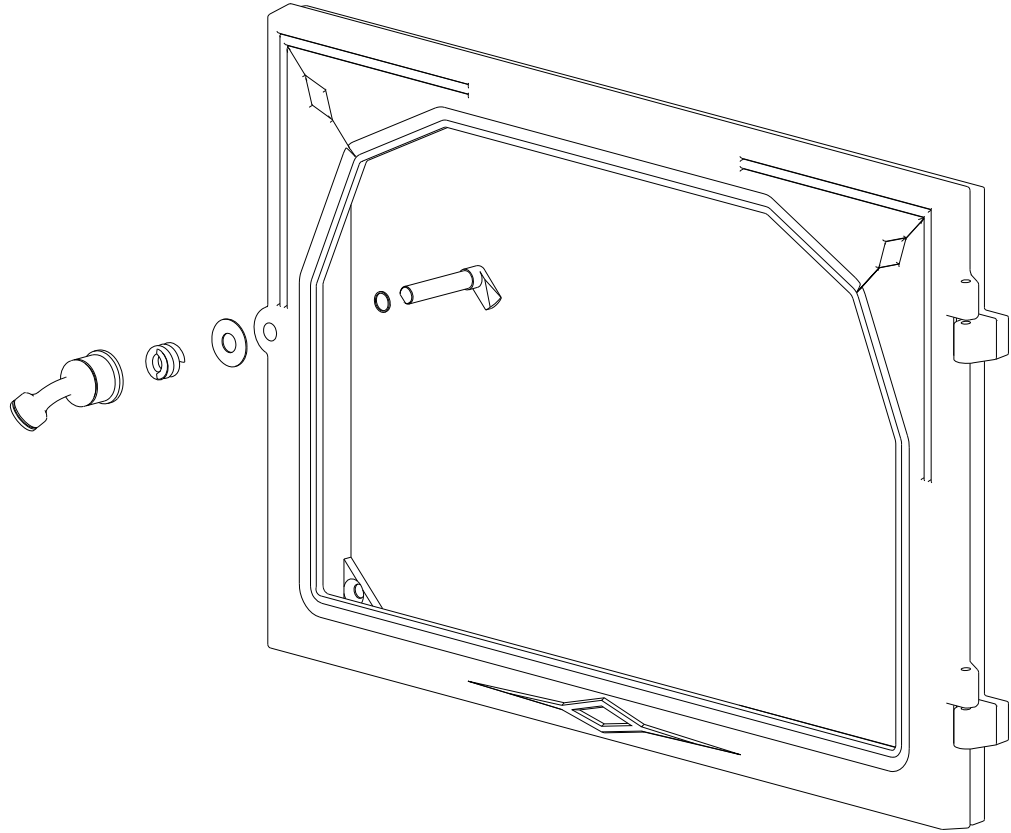
Figure 1
Exploded view of latch components

2. Install the new latch assembly as shown in the illustration. Begin with two shim spacers placed on the latch shaft. Push the threaded end of the latch shaft through the door so the threads are on the outside of the door.

3. Place the large washer over the threaded portion of the latch shaft and then slide the coil spring over the shaft of the latch so that it rests on top of the washer. Thread the chrome crank onto the latch and over the coil spring. Turn the crank until there is approximately 1/8" between the crank and the washer.

4. Align the setscrew hole in the crank with the groove on the latch shaft. Insert and tighten the setscrew. Turn the latch back and forth while tightening to seat the setscrew fully in the groove.
